TECH4203- TDS_T6.2
Developed Investigation A1 sheets
C193893996-Shannen Celeste

HOW DOES ENVIRONMENTAL CONDITIONS AFFECT MOULD GROWTH

CASE STUDY

END-OF-TERRACE HOUSE

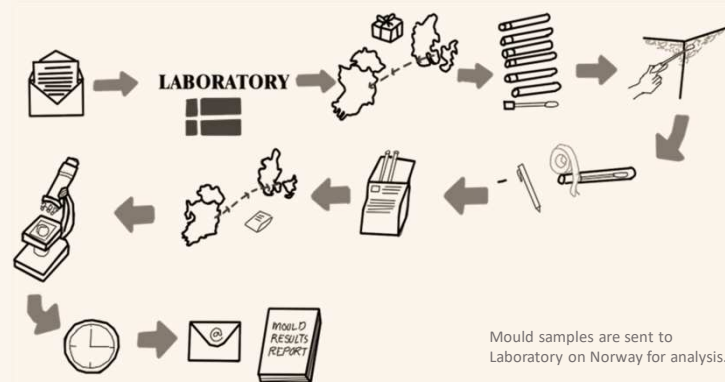
LABORATORY ANALYSIS

Our analysis shows that there are very high levels of mould in the sample. The species composition of the mould is abnormal and there are very high levels of mould species that thrive in damp indoor environments. This means that there is likely to be a damp problem in the building that is adversely affecting the indoor air quality.

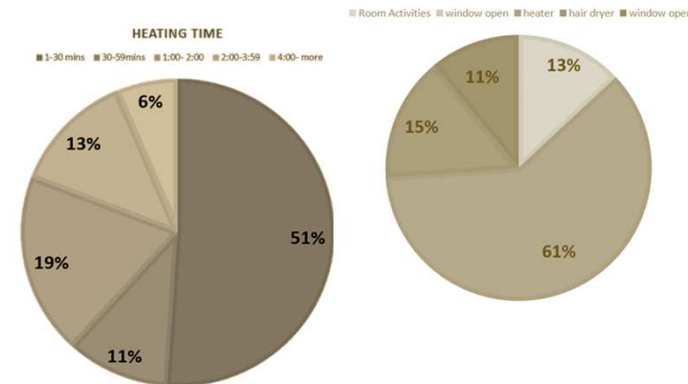
BEDROOM ACTIVITIES

WEEKEND is the most CRITICAL day for Mould Growth

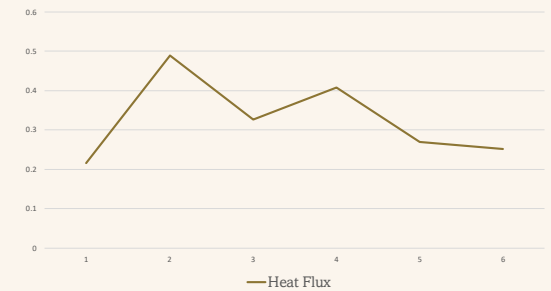
Bedroom Wall Heat flux

Using Scientific Method of heat flux data logging, I was able to find out that there's a Thermal looping happening in the service cavity of the wall. Heat flux was installed to the wall according to the standards, however the results are giving 0 heat transfer. Upon investigating, it was found that ventilation ducts in walls are not sealed. There are also few existing holes in the wall causing air movement.

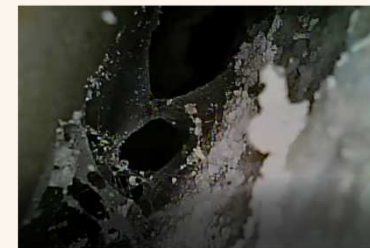
Inspection Camera inside the service cavity of Bedroom Wall

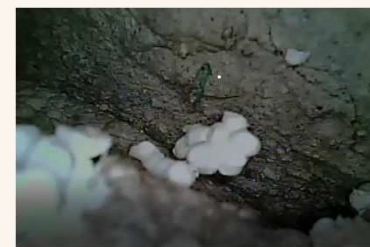
Inspection Camera inside the service cavity of Kitchen Wall

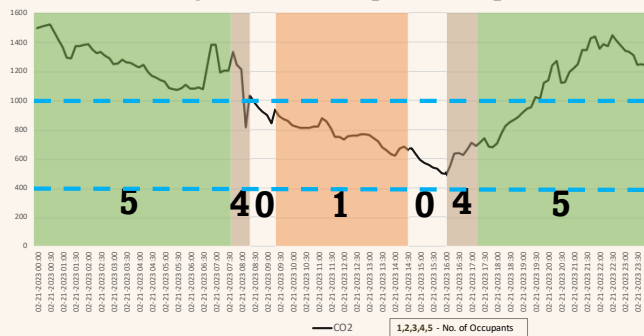
1 Day-CO2 & Occupants Graph

Human activities together with the building design, contributes highly to the development of moulds. High CO2 activities like laundry indoor drying, showering and cooking can cause CO2 levels to rise up to 2800ppm. More than twice the recommended healthy air of 400-1000 ppm by the Wisconsin Department of Health Services. Without opening windows or doors during these activities shows that the ventilation alone in the dwelling is not enough to eliminate the poor air quality.

- Opening Windows and Doors for at least 10 mins
- Upgrade Ventilation with Mechanical Heat Recovery Ventilation
- Avoid Drying Laundry Indoor and with a heater
