# Can Pre-Regulation Office Buildings be retrofitted to current NZEB standards in order to reduce its Net Carbon Output?

## Existing Liberty Hall Technical Exploration

## Liberty Hall Retrofit Proposal

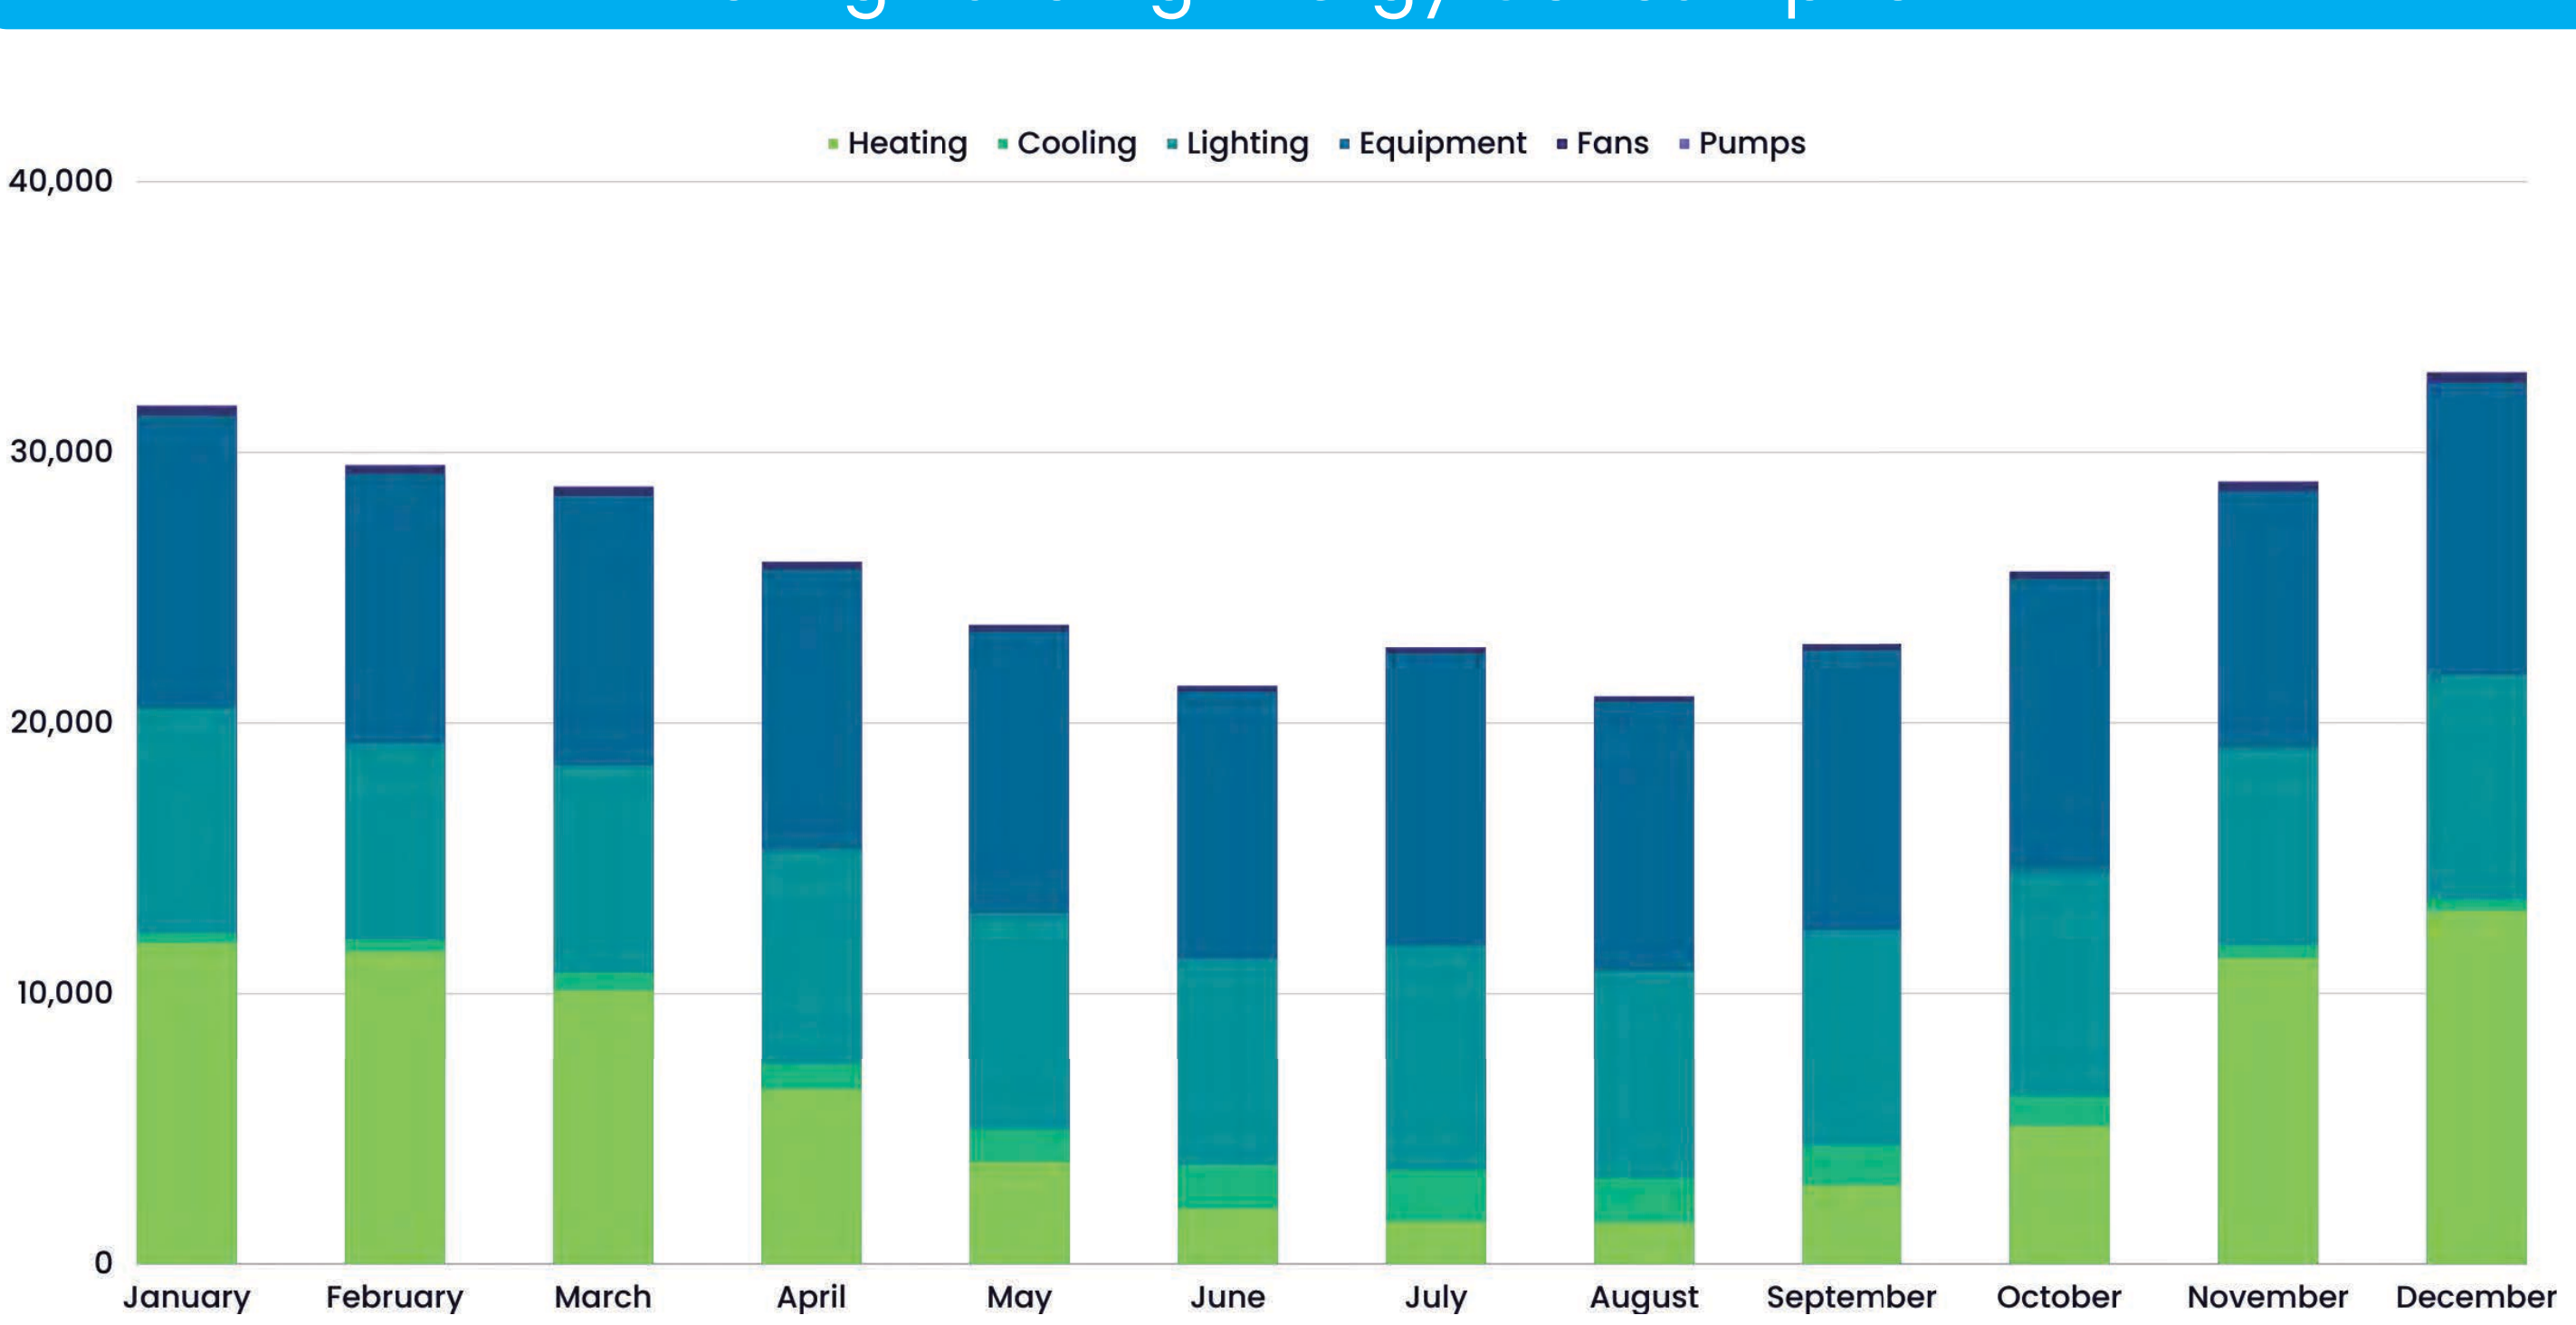
### Existing Building Energy Consumption

314533 kWh consumed per annum × Old Equipment Factor of 2 = 629066 kWh/yr

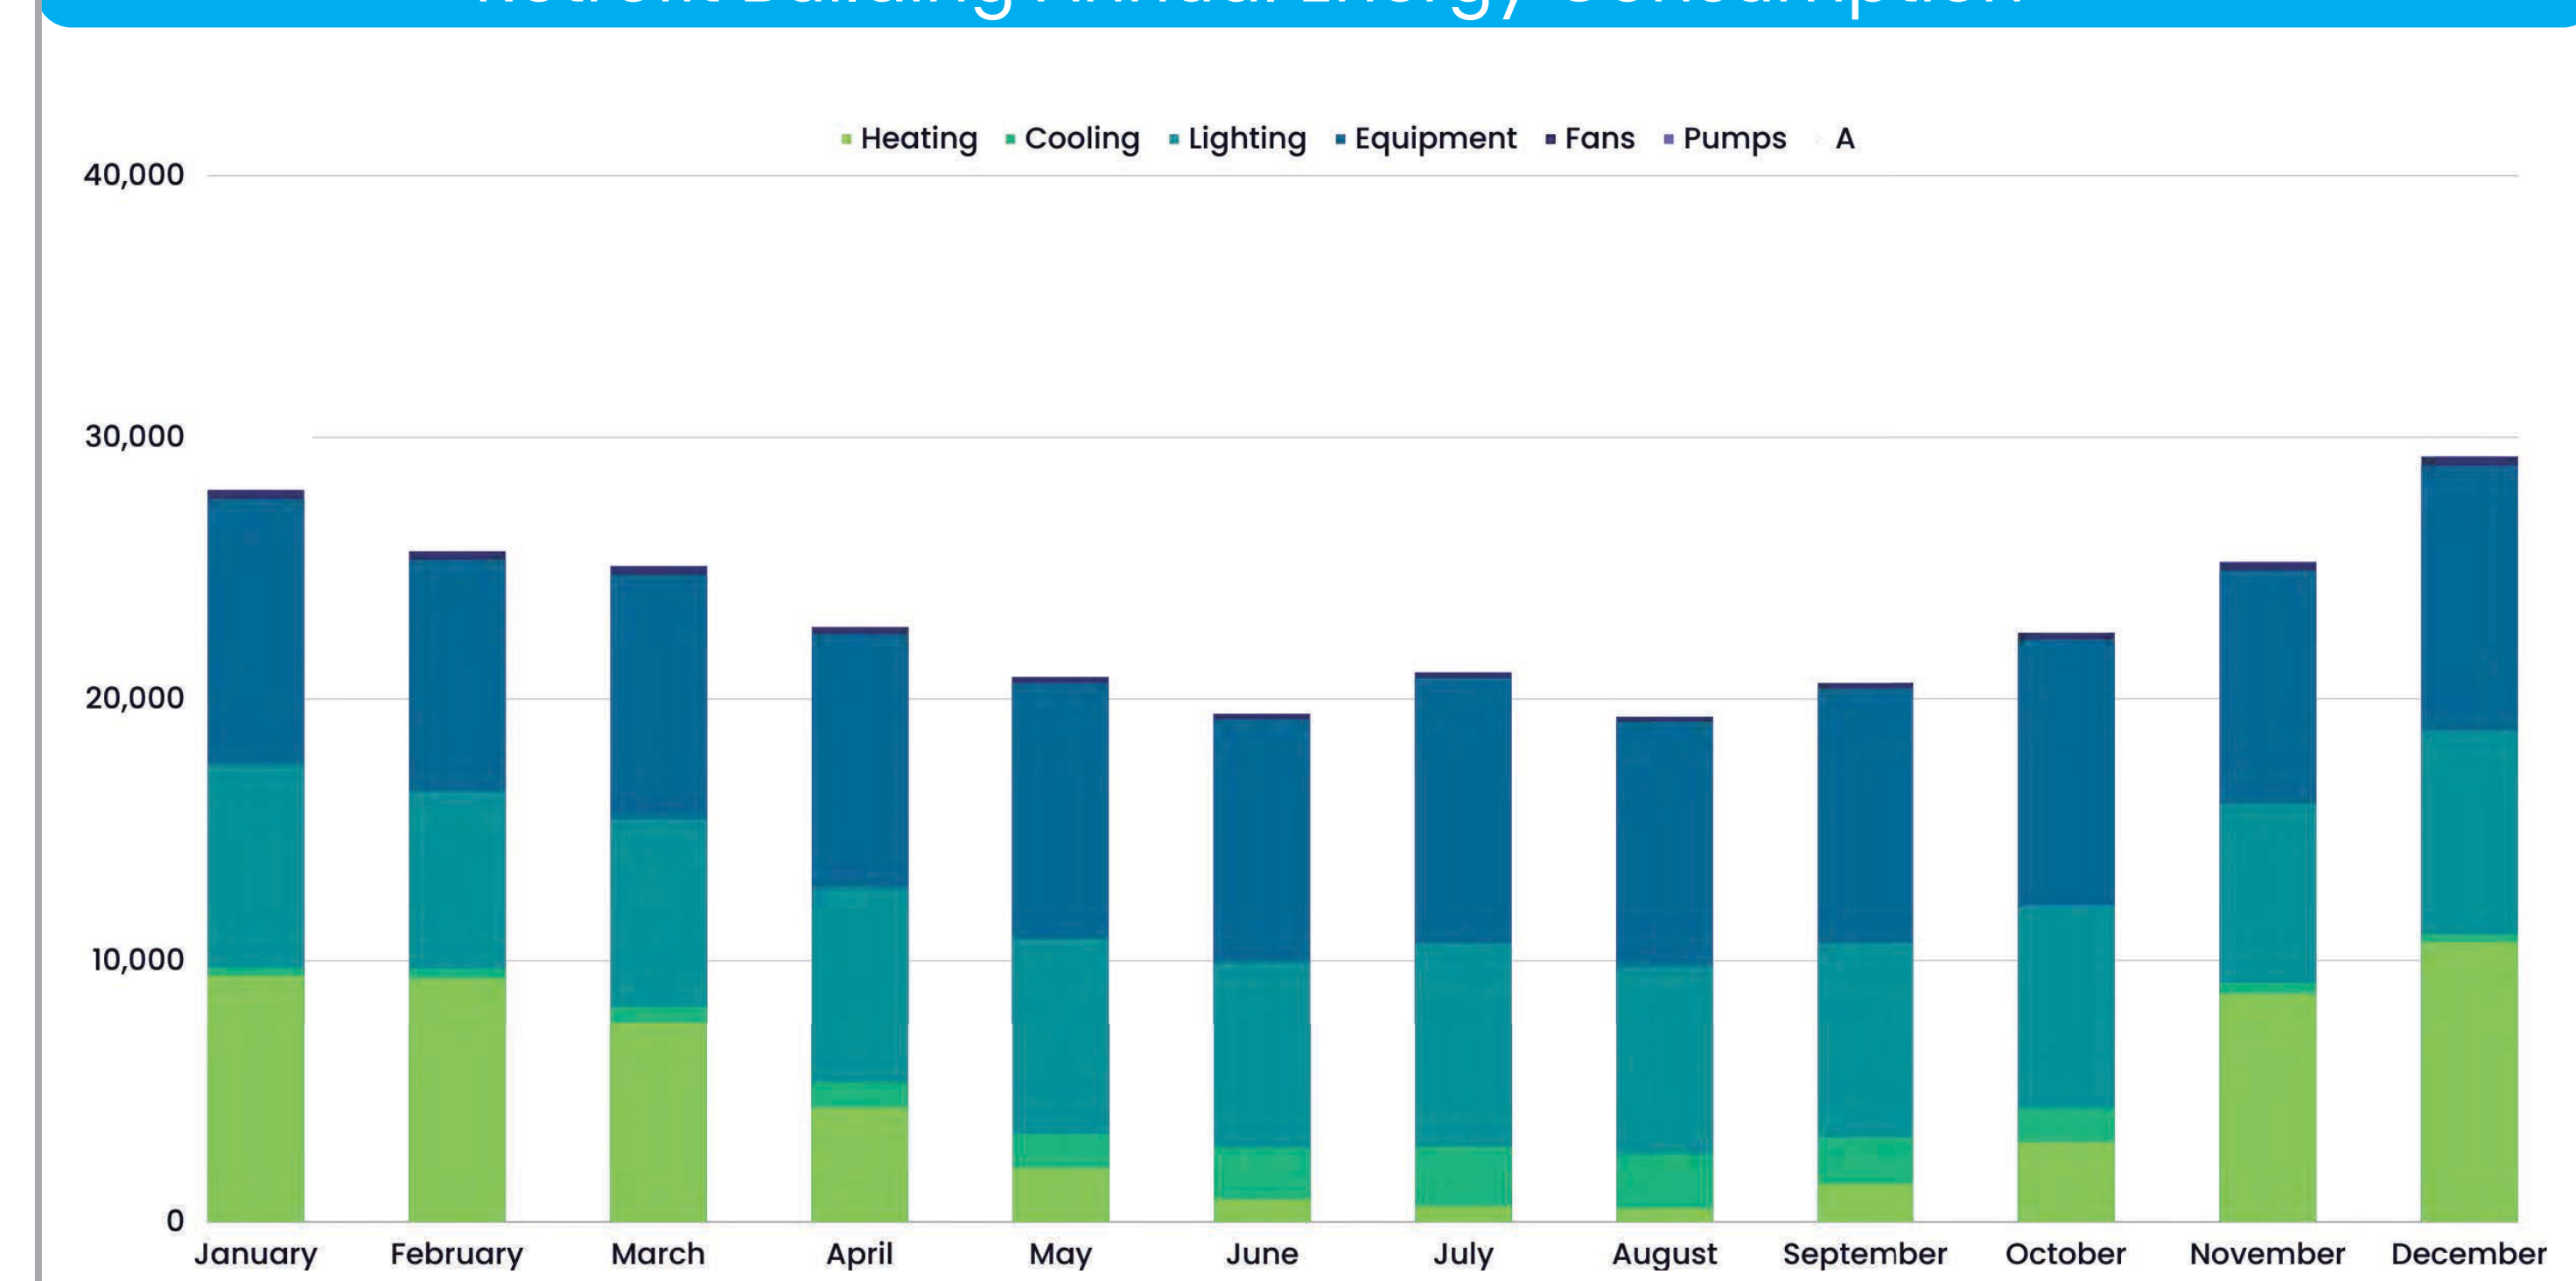
### Retrofit Building Annual Energy Consumption

The Retrofit Proposal of Liberty Hall consumed 70% less energy per annum than the Existing Liberty Hall Building
